# Cu-Pillar Bump Probing: Utilizing a 50 $\mu$ m Pitch Fine Pitch Vertical Probe Card Technology

Senthil Theppakuttai, Ph.D.

SV Probe

**IEEE SW Test Workshop**  
Semiconductor Wafer Test Workshop

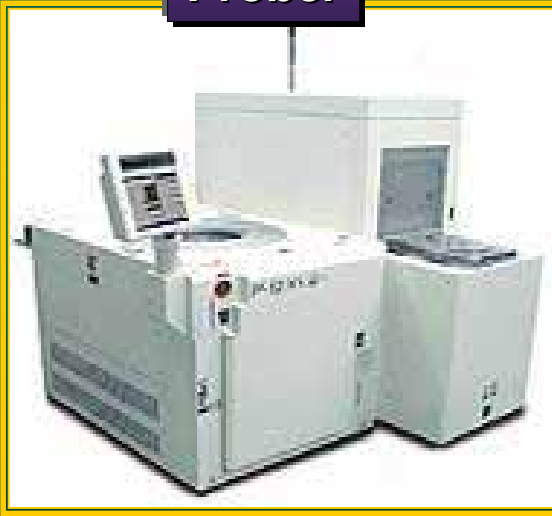
Prober

- Test Chip Designed by ASE
- LT50 Probe Card by SV Probe
- P-12 XLn Prober, HP93000 Tester
- Microscope, SEM, Veeco Profilometer

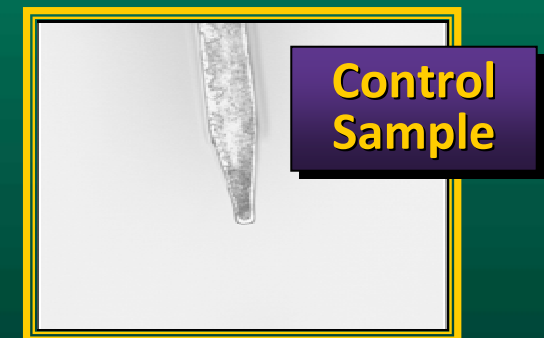
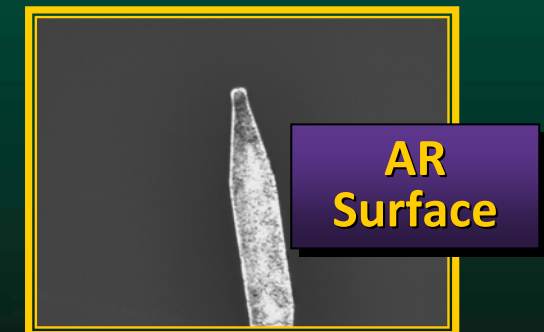
## P-12 Prober

*P-12 Prober Pictures: High Mag, Light Level 120, Focused 7-8 mils above Die Surface*

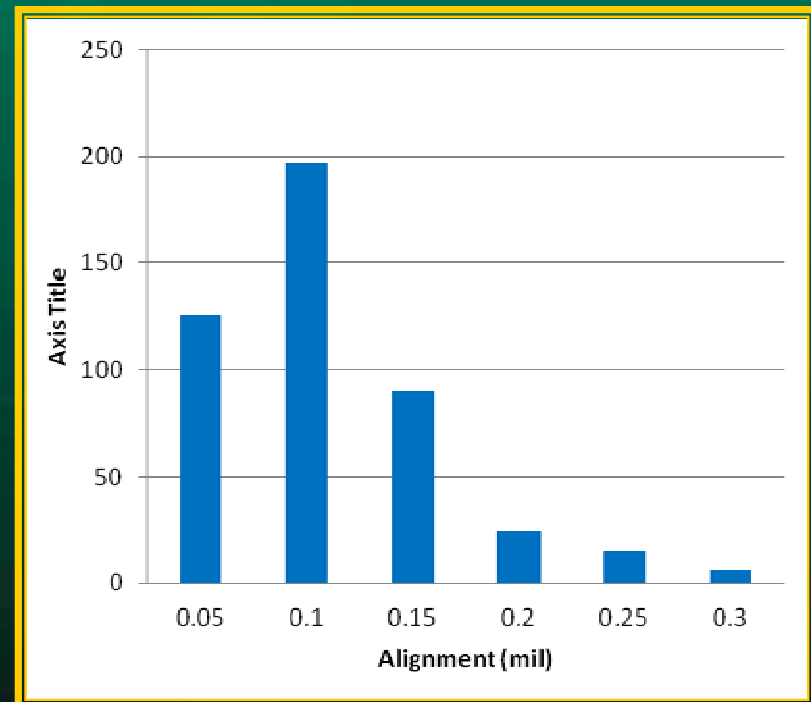
- Probe Tip Alignment – 0.3 mil Radial

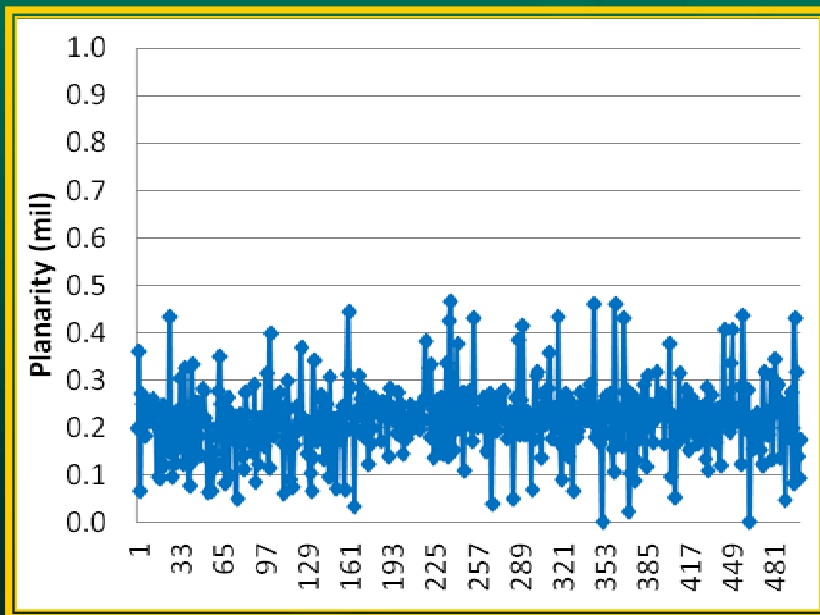
- Probe Planarity 0.45 mil (12 $\mu$ m)

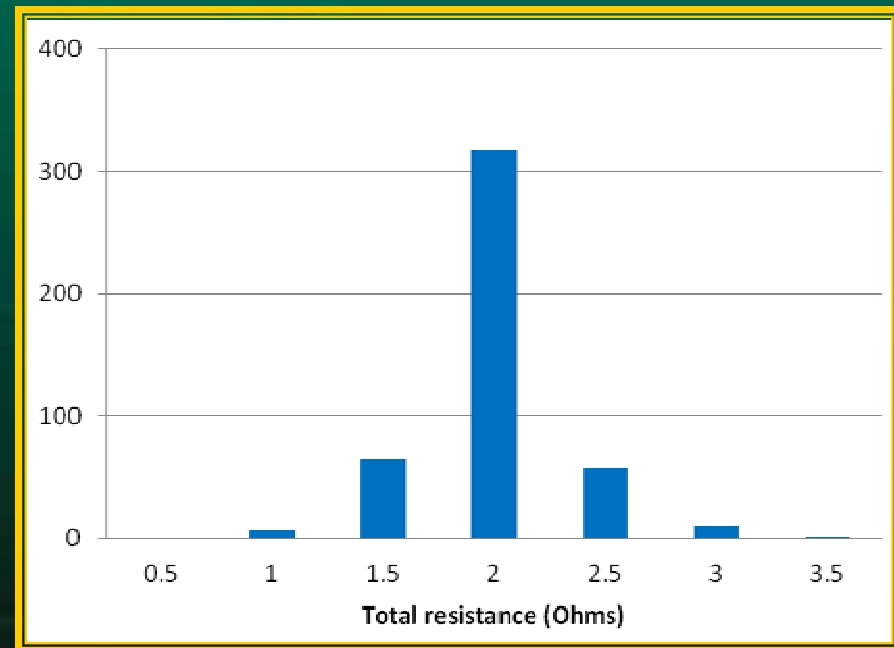
- Max Total Resistance is 3.2 Ohms (includes Cres & Path Resistance through PH, MST & PCB)
